ARBORIST REPORT, TREE PROTECTION PLAN AND INVENTORY
CY CARLBERG - 2008

EVALUATION OF PROPOSED CONSTRUCTION ADJACENT TO
TREES AT THE GUASTI VILLA IN
ONTARIO, CALIFORNIA

AUGUST 13, 2007

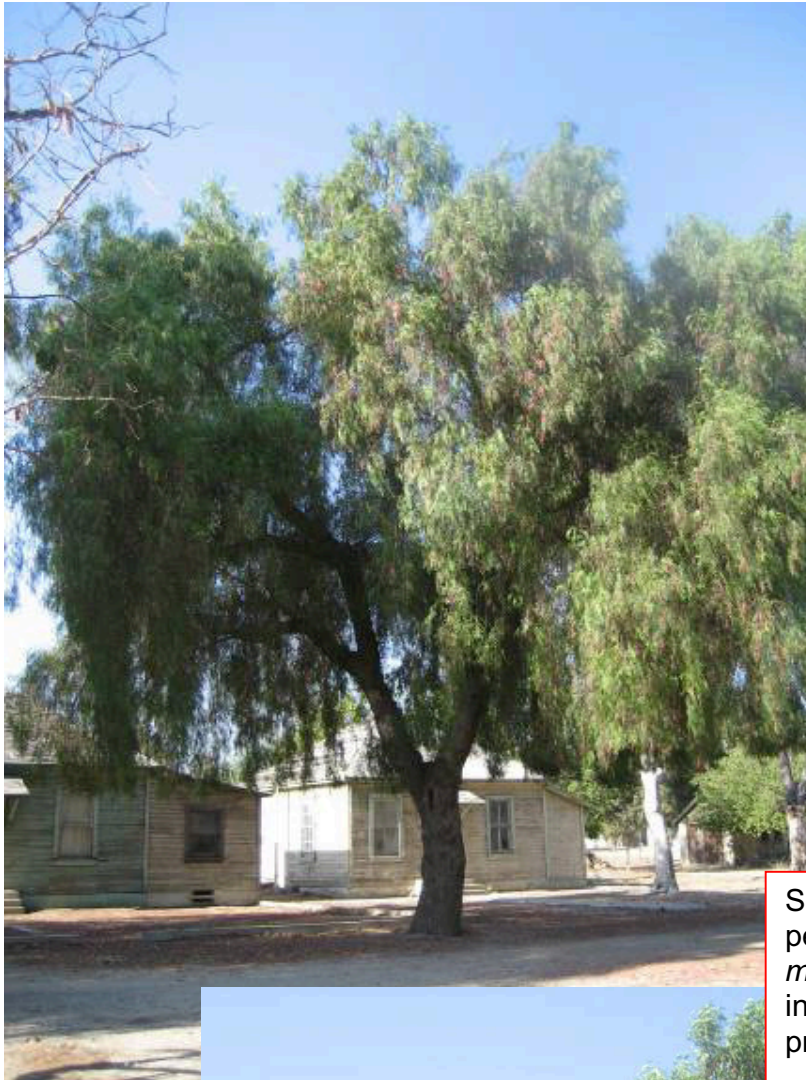
Showing two California pepper trees (*Schinus molle*) proposed to be incorporated into the project design.

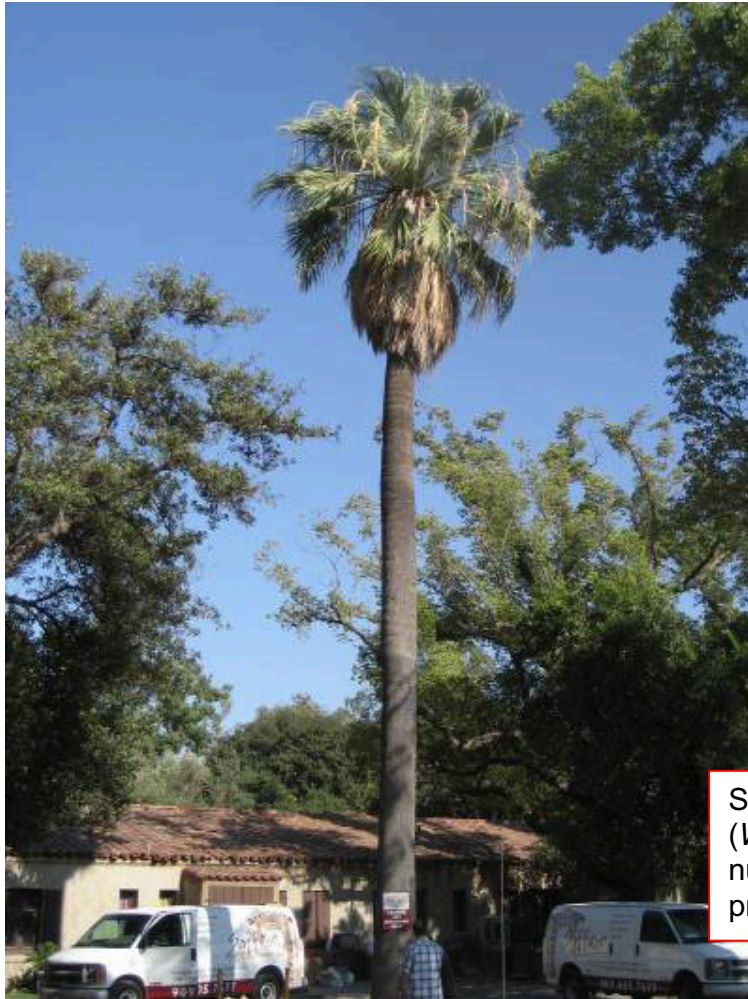
Showing a California fan palm (*Washingtonia filifera*) and a number of eucalyptus trees proposed to be retained.

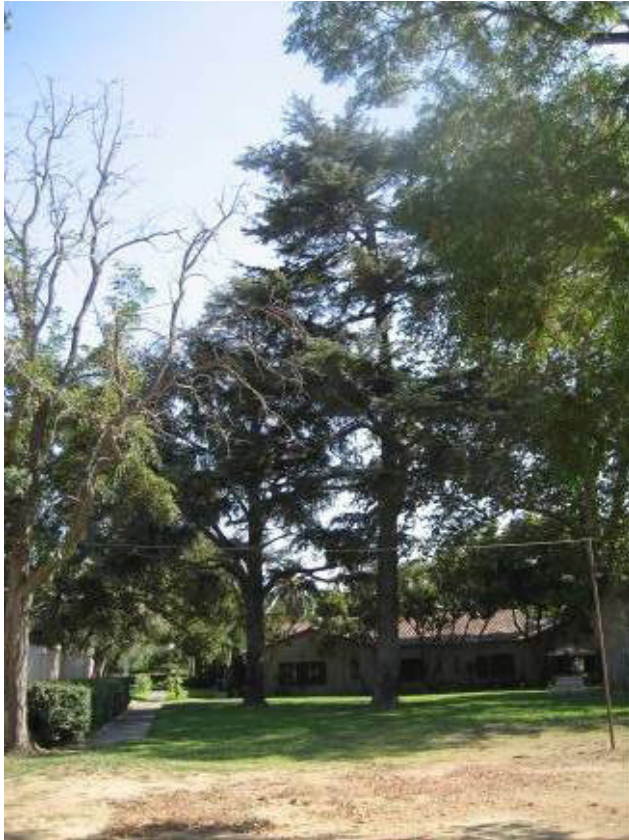
Showing a number of deodar cedars (*Cedrus deodara* and *Cedrus atlantica* 'Glaucua') to be preserved.

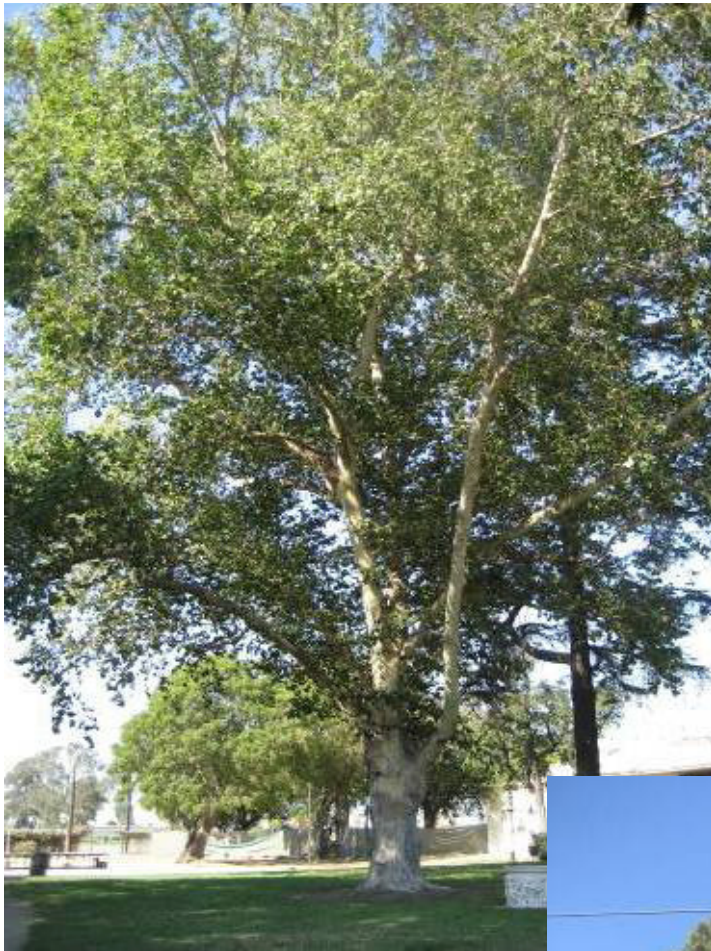
Showing a London plane tree (*Platanus x acerifolia*) and an Italian stone pine (*Pinus pinea*) proposed to be retained.

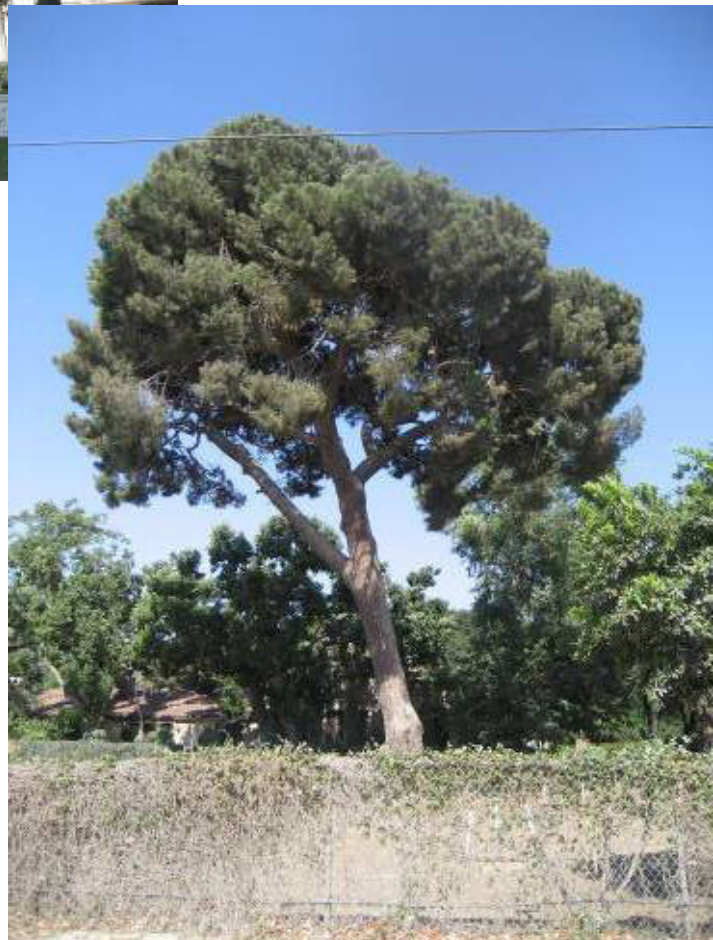
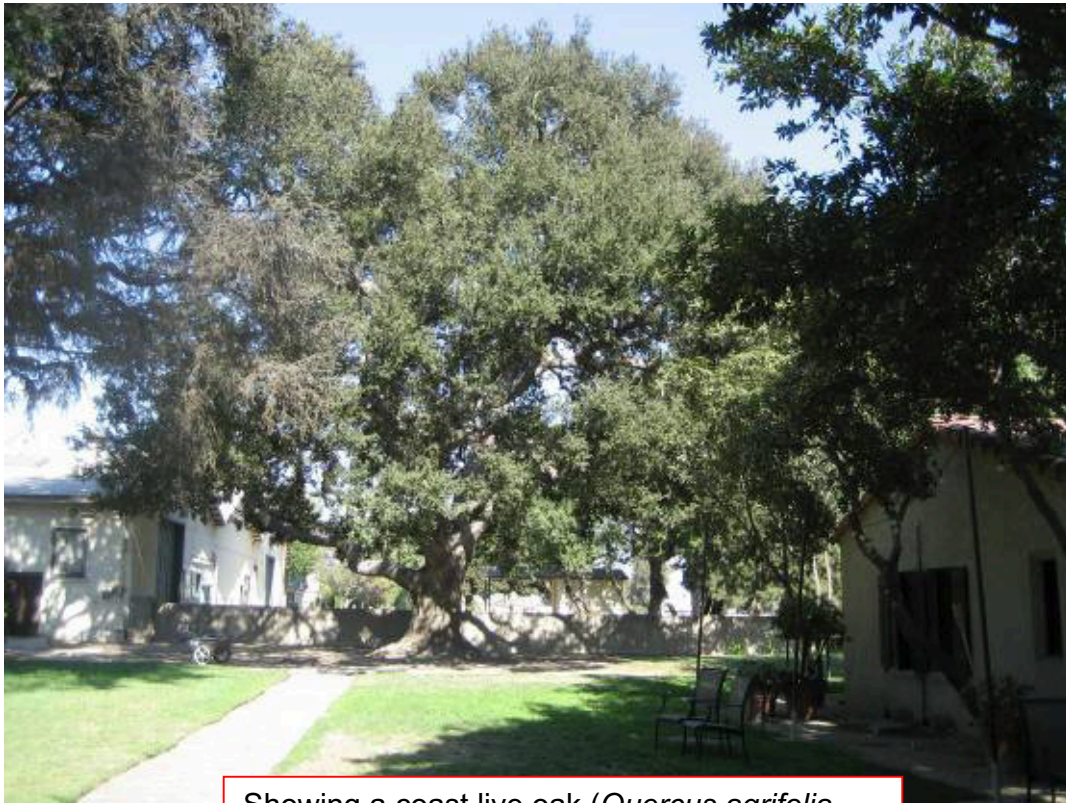
Showing a coast live oak (*Quercus agrifolia*--above) and a camphor tree (*Cinnamomum camphora*) and cork oak (*Quercus suber*—below) proposed to be retained.
