**CITY OF ONTARIO HISTORIC PRESERVATION
COMMISSION
HISTORIC PRESERVATION SUBCOMMITTEE**

**SPECIAL MEETING
AGENDA**

NOVEMBER 10, 2021

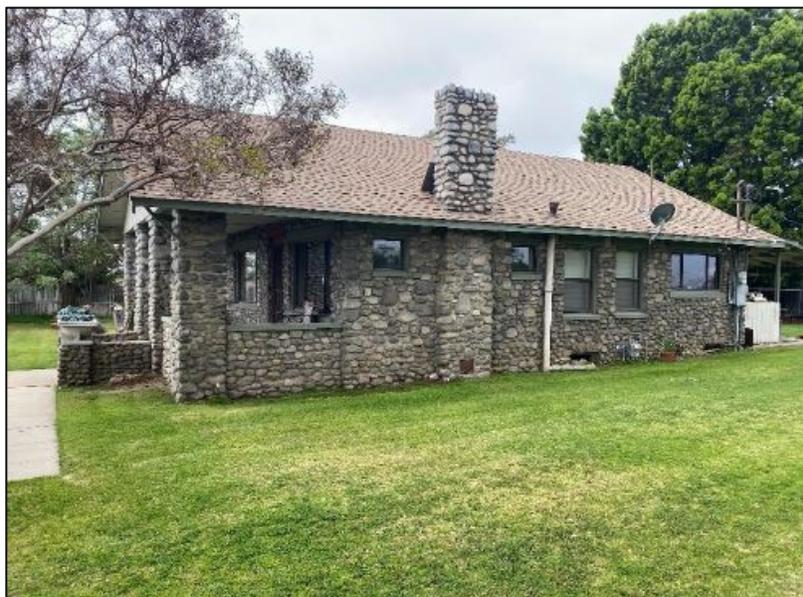
North Elevation

The northern façade has minimal eave overhang and window types including single-hung, fixed, and Chicago-style aluminum. An end-wall chimney constructed with stone is located near the eastern end of the façade. The stone of the chimney above the roofline appears to have been repaired as the spacing and color of the mortar does not match the remainder of the building.

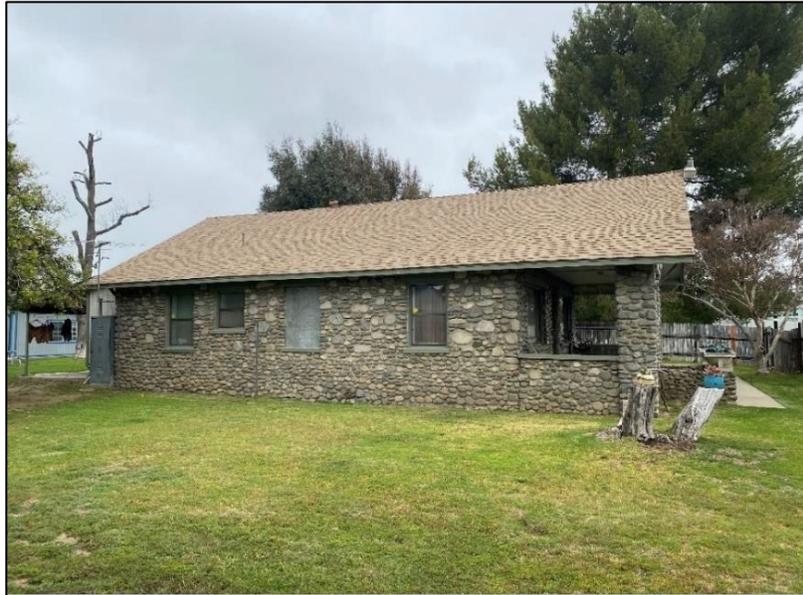
South Elevation

The southern façade has minimal eave overhang. The façade has three single-hung aluminum windows with wood surrounds and concrete headers. The fourth window near the center of the façade has been boarded. The northern façade has minimal eave overhang and window types including single-hung, fixed, and Chicago-style. An end-wall chimney constructed with stone is located near the eastern end of the façade. The stone of the chimney above the roofline appears to have been repaired as the spacing and color of the mortar does not match the remainder of the building. The western (rear) façade has an enclosed porch addition and concrete patio with shed roof supported by metal posts from unknown dates. There is thin horizontal wood clapboard and a square louver vent in the gable and three triangular knee braces under the eave. The enclosed porch addition is clad in vertical wood clapboard and does not span the entire façade, ending

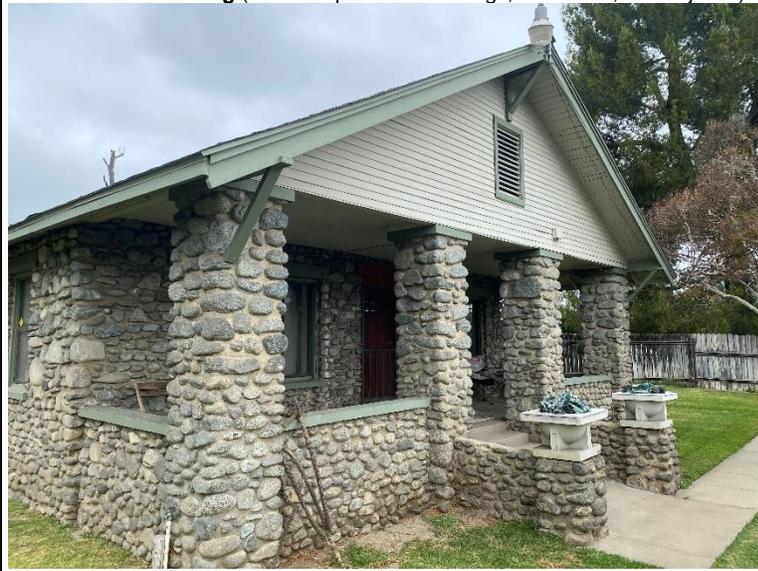
P5b. Description of Photo (view, date, accession #): Primary façade; view northwest; April 13, 2021

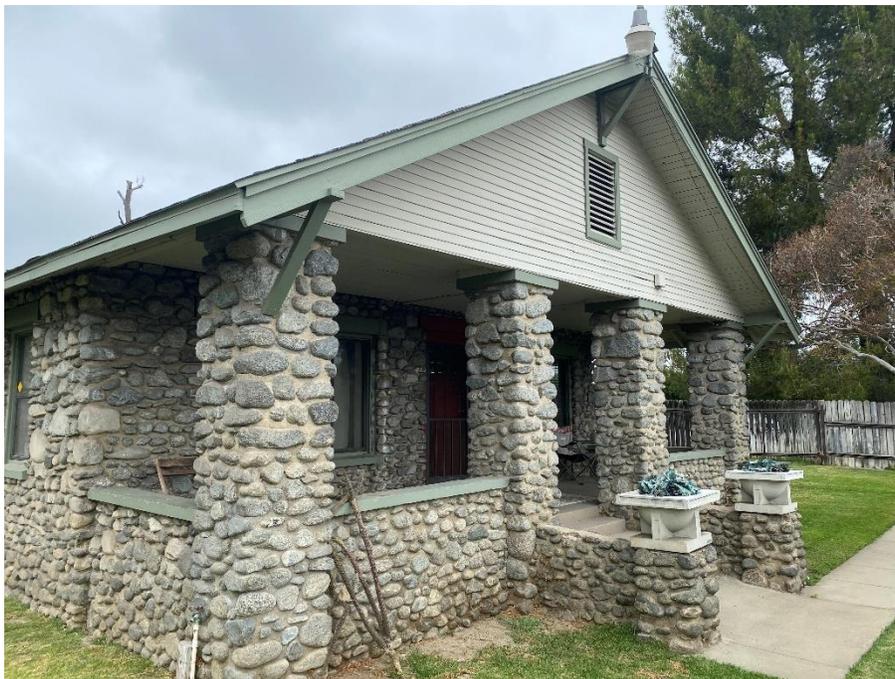
Primary Façade, 1948 S. Bon View Avenue
SOURCE: Panattoni Development Co, Inc., 2021

Residence

The residence located at the eastern end of the parcel has a rectangular footprint, a medium-pitched front-facing gabled roof and is clad in stone on all façades. The primary façade of the residence is symmetrical with thin horizontal wood clapboard and a square louver vent in the front-facing gable and triangular knee braces under the eaves. The primary façade is defined by its full-façade porch with four square columns clad in stone that extend from the roofline to the ground level. The primary façade is inset below the primary roofline. The porch is enclosed with an approximately 2-foot-tall wall clad in stone with a flat wood balustrade. A stoop constructed of stone, extends from the center of the porch with concrete planters set on top of the end caps. The primary wood entrance door with divided lights along the top, and a bold concrete header along the top, is centrally located and is covered by a screen door. The door is flanked by aluminum Chicago-style windows with sliding sides and a central fixed light. Both windows also have bold concrete headers and wood surrounds.

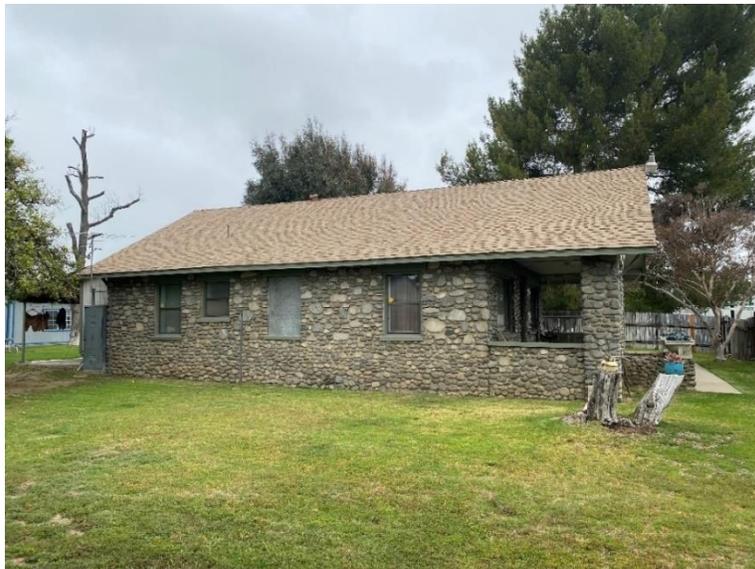
Southern Façade, 1948 S. Bon View Avenue
SOURCE: Panattoni Development Co, Inc., 2021

Southern Façade

The southern façade has minimal eave overhang. The façade has three single-hung aluminum windows with wood surrounds and concrete headers. The fourth window near the center of the façade has been boarded.

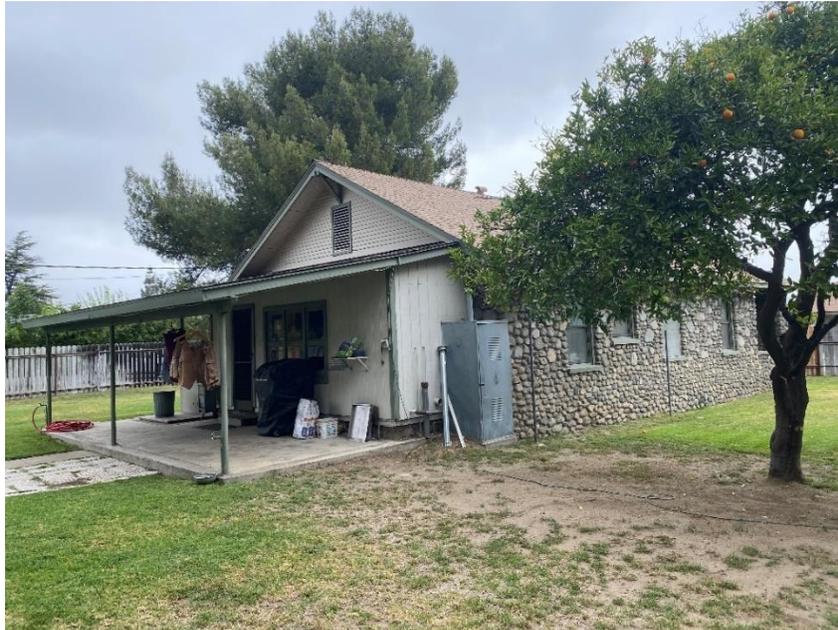
Western Façade, 1948 S. Bon View Avenue
SOURCE: Panattoni Development Co, Inc., 2021

Western Façade

The western (rear) façade has an enclosed porch addition and concrete patio with shed roof supported by metal posts from unknown dates. There is thin horizontal wood clapboard and a square louver vent in the gable and three triangular knee braces under the eave. The enclosed porch addition is clad in vertical wood clapboard and does not span the entire façade, ending just before the northern end. The entrance is generally centrally located with a triplet of wood windows to the south.

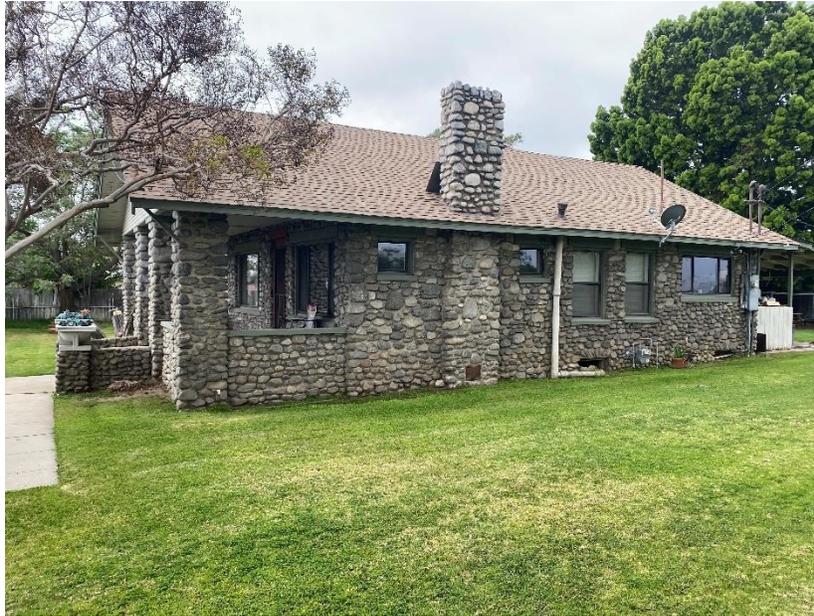
Northern Façade, 1948 S. Bon View Avenue
SOURCE: Panattoni Development Co, Inc., 2021

Northern Façade

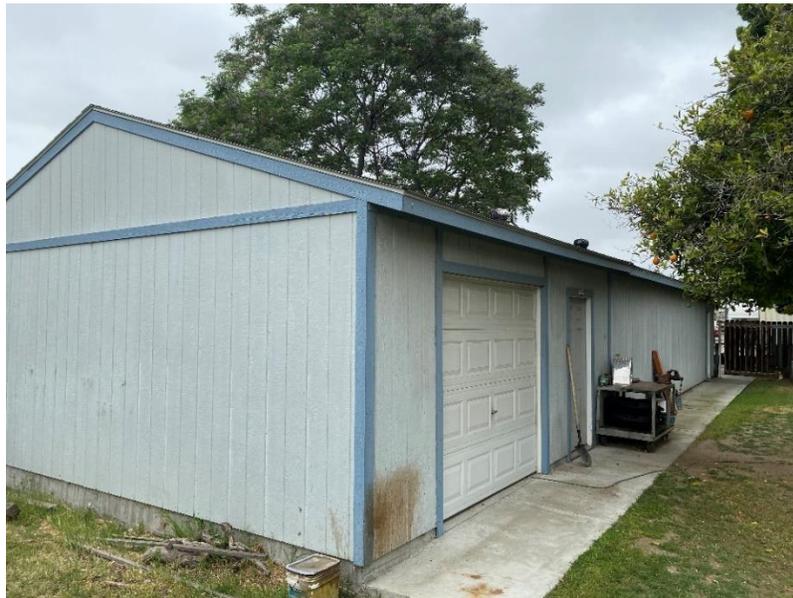
Detached Garage, 1948 S. Bon View Avenue
SOURCE: Panattoni Development Co, Inc., 2021

Detached Garage

The detached garage was added before 1980 to the southwest of the residence. The building has a rectangular footprint, a gabled roof, and is clad in vertical wood clapboard. A metal roll-up door and modern pedestrian door are located on the northern façade.

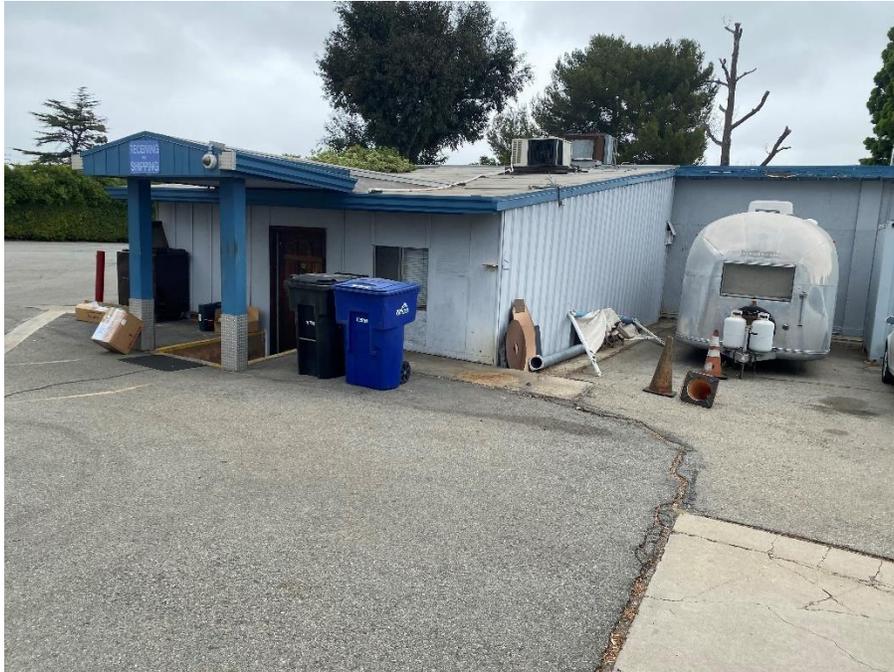
Commercial Building, 1948 S. Bon View Avenue
SOURCE: Panattoni Development Co, Inc., 2021

Commercial Building

An 'L'-shaped commercial building is located behind the residential building to the west and was added to the lot between 1966 and 1980. The building is clad in board and batten and horizontal wood clapboard siding. It has a generally flat roof with some slope, and its primary entrance is located on the western façade of the building. The entrance is set below ground level and is accessed by concrete steps built into the lot. The entrance is covered by an extended gabled portico supported by square posts.

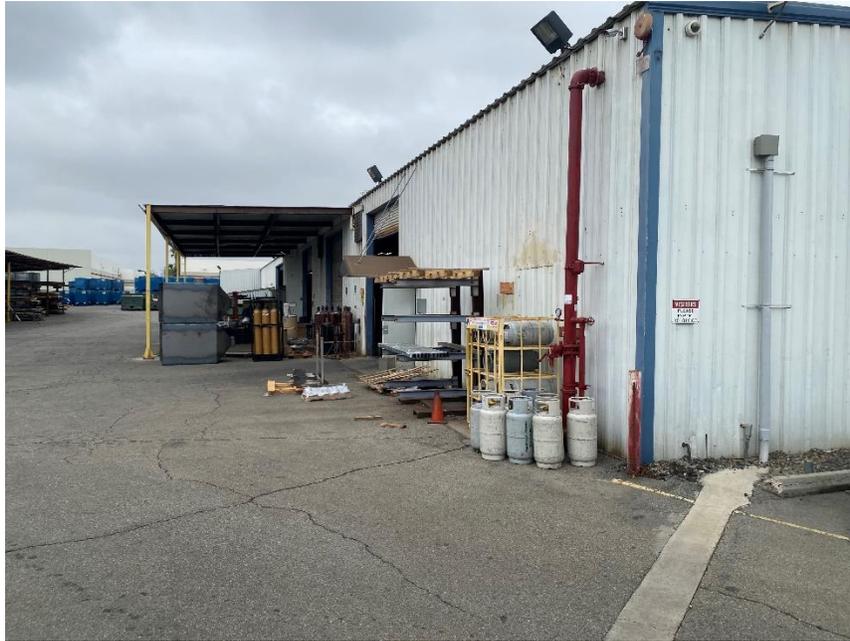
Northern Industrial Building, 1948 S. Bon View Avenue
SOURCE: Panattoni Development Co, Inc., 2021

Between 1966 and 1980 the two industrial buildings were constructed near the center of the lot. The northern building was constructed first. The building has a rectangular footprint, is clad in corrugated sheet metal, and has a gabled roof with a low pitch. The southern façade has full-height loading bays with metal roll-up doors. A wide flat roof cover extends off the center of the building at the roofline shielding the central loading bays and is supported by metal posts. The southern industrial building has a square footprint, is clad in plywood, and has a flat roof with a slight southern pitch. There is one full-height loading bay on the northern façade, and a flat roof cover extends off the western façade from the roofline supported by metal posts.

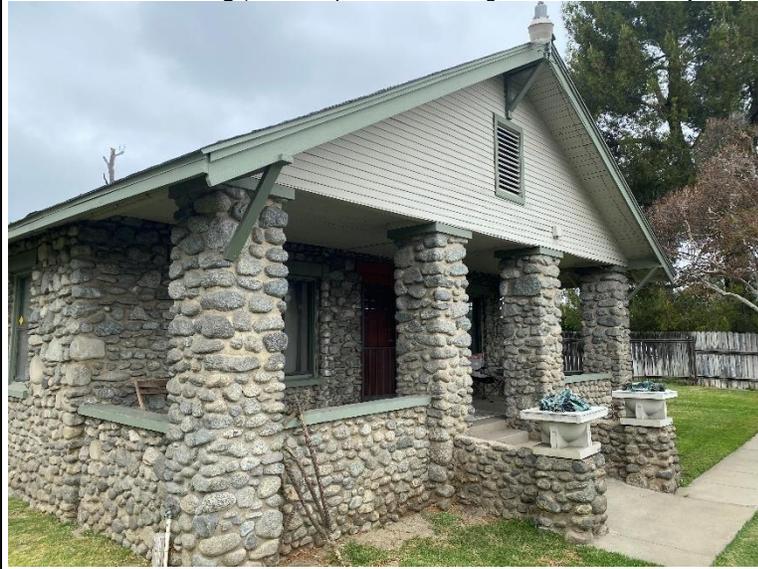
P5b. Description of Photo (view, date, accession #): Primary façade; view northwest; April 13, 2021

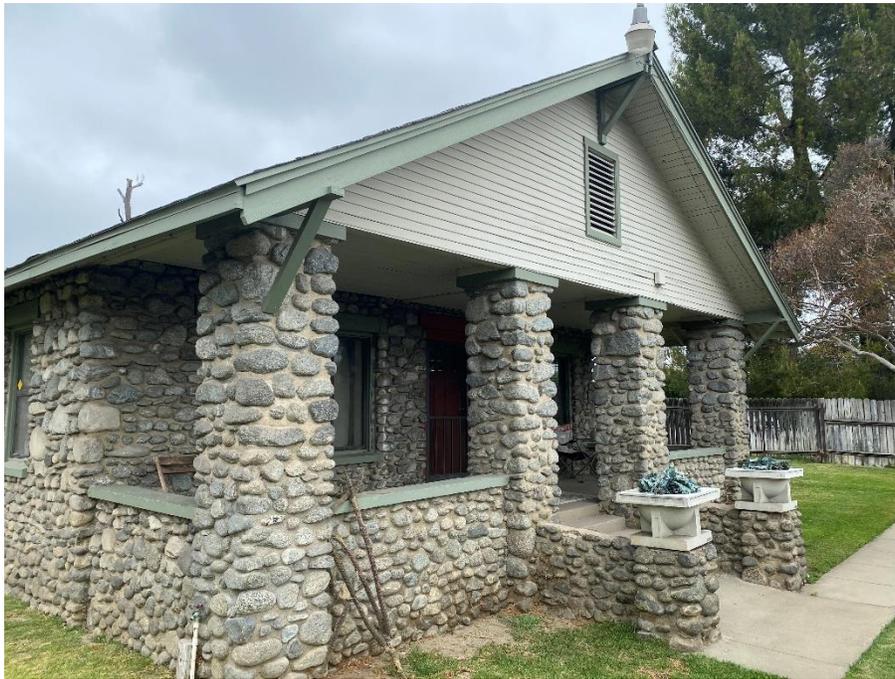
Primary Façade, 1948 S. Bon View Avenue
SOURCE: Panattoni Development Co, Inc., 2021

Residence

The residence located at the eastern end of the parcel has a rectangular footprint, a medium-pitched front-facing gabled roof and is clad in stone on all façades. The primary façade of the residence is symmetrical with thin horizontal wood clapboard and a square louver vent in the front-facing gable and triangular knee braces under the eaves. The primary façade is defined by its full-façade porch with four square columns clad in stone that extend from the roofline to the ground level. The primary façade is inset below the primary roofline. The porch is enclosed with an approximately 2-foot-tall wall clad in stone with a flat wood balustrade. A stoop constructed of stone, extends from the center of the porch with concrete planters set on top of the end caps. The primary wood entrance door with divided lights along the top, and a bold concrete header along the top, is centrally located and is covered by a screen door. The door is flanked by aluminum Chicago-style windows with sliding sides and a central fixed light. Both windows also have bold concrete headers and wood surrounds.

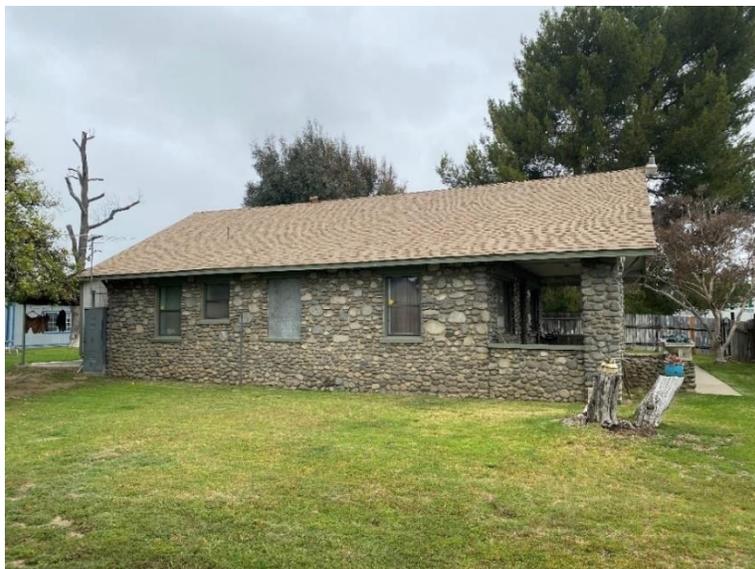
Southern Façade, 1948 S. Bon View Avenue
SOURCE: Panattoni Development Co, Inc., 2021

Southern Façade

The southern façade has minimal eave overhang. The façade has three single-hung aluminum windows with wood surrounds and concrete headers. The fourth window near the center of the façade has been boarded.

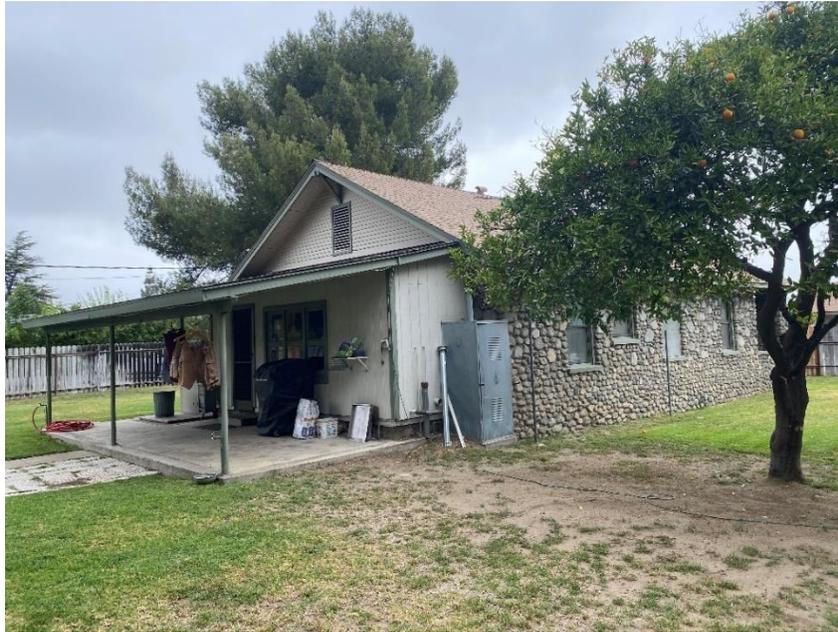
Western Façade, 1948 S. Bon View Avenue
SOURCE: Panattoni Development Co, Inc., 2021

Western Façade

The western (rear) façade has an enclosed porch addition and concrete patio with shed roof supported by metal posts from unknown dates. There is thin horizontal wood clapboard and a square louver vent in the gable and three triangular knee braces under the eave. The enclosed porch addition is clad in vertical wood clapboard and does not span the entire façade, ending just before the northern end. The entrance is generally centrally located with a triplet of wood windows to the south.

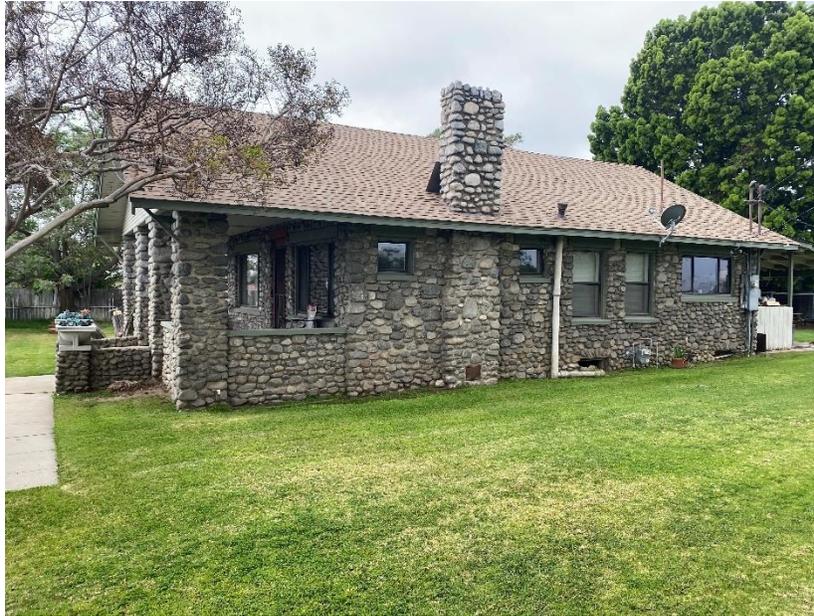
Northern Façade, 1948 S. Bon View Avenue
SOURCE: Panattoni Development Co, Inc., 2021

Northern Façade

The northern façade has minimal eave overhang and window types including single-hung, fixed, and Chicago-style aluminum. An end-wall chimney constructed with stone is located near the eastern end of the façade. The stone of the chimney above the roofline appears to have been repaired as the spacing and color of the mortar does not match the remainder of the building.

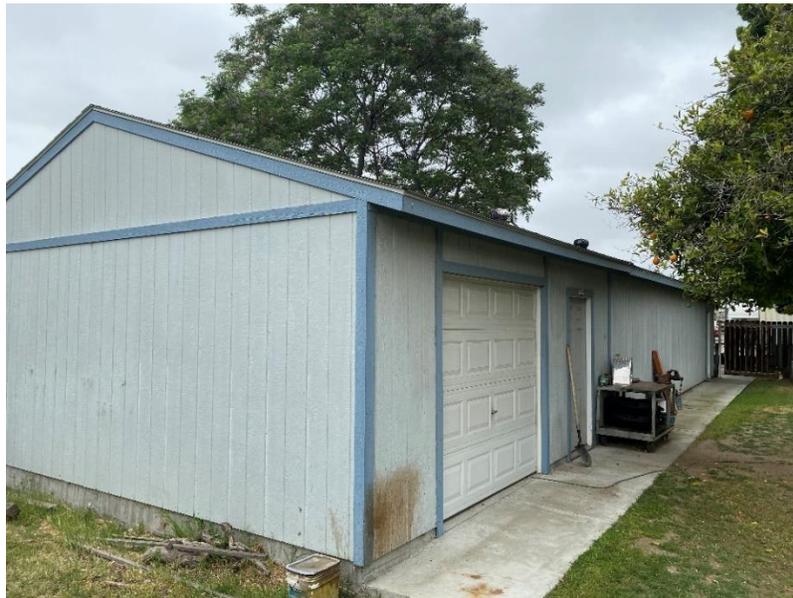
Detached Garage, 1948 S. Bon View Avenue
SOURCE: Panattoni Development Co, Inc., 2021

Detached Garage

The detached garage was added before 1980 to the southwest of the residence. The building has a rectangular footprint, a gabled roof, and is clad in vertical wood clapboard. A metal roll-up door and modern pedestrian door are located on the northern façade.

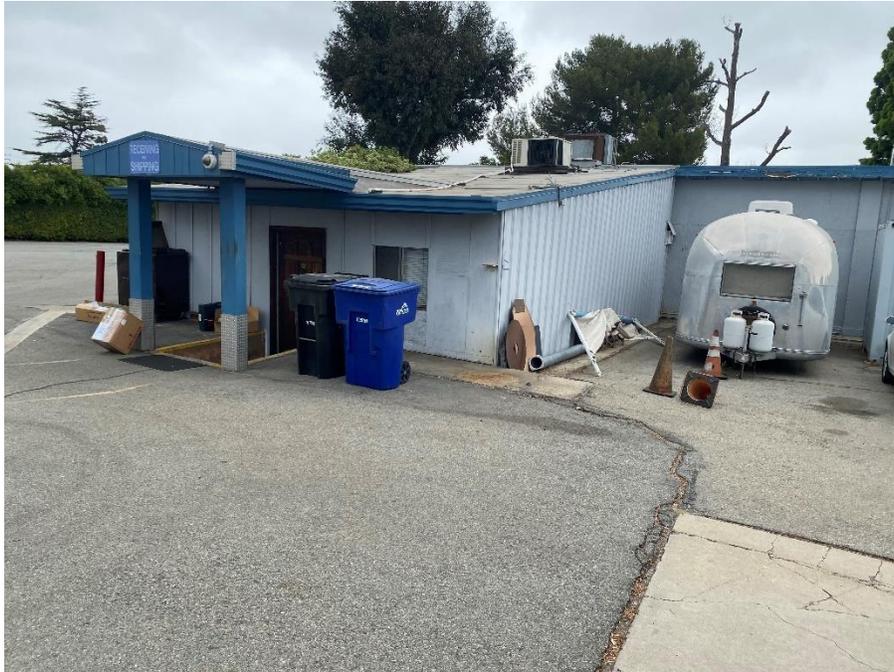
Commercial Building, 1948 S. Bon View Avenue
SOURCE: Panattoni Development Co, Inc., 2021

Commercial Building

An 'L'-shaped commercial building is located behind the residential building to the west and was added to the lot between 1966 and 1980. The building is clad in board and batten and horizontal wood clapboard siding. It has a generally flat roof with some slope, and its primary entrance is located on the western façade of the building. The entrance is set below ground level and is accessed by concrete steps built into the lot. The entrance is covered by an extended gabled portico supported by square posts.

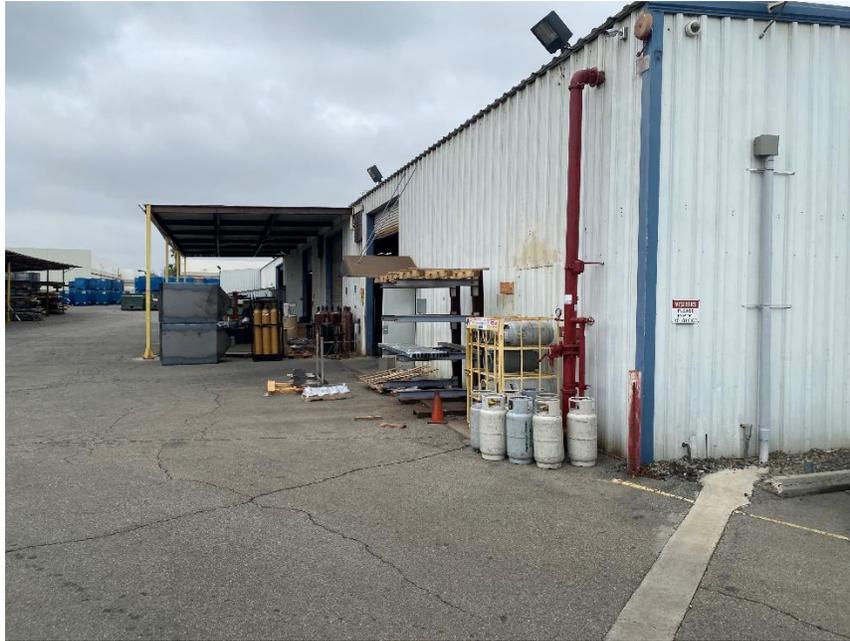
Northern Industrial Building, 1948 S. Bon View Avenue
SOURCE: Panattoni Development Co, Inc., 2021

Between 1966 and 1980 the two industrial buildings were constructed near the center of the lot. The northern building was constructed first. The building has a rectangular footprint, is clad in corrugated sheet metal, and has a gabled roof with a low pitch. The southern façade has full-height loading bays with metal roll-up doors. A wide flat roof cover extends off the center of the building at the roofline shielding the central loading bays and is supported by metal posts. The southern industrial building has a square footprint, is clad in plywood, and has a flat roof with a slight southern pitch. There is one full-height loading bay on the northern façade, and a flat roof cover extends off the western façade from the roofline supported by metal posts.

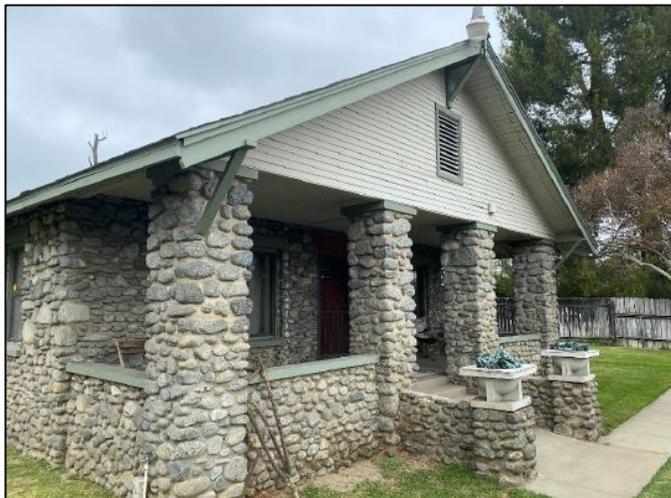
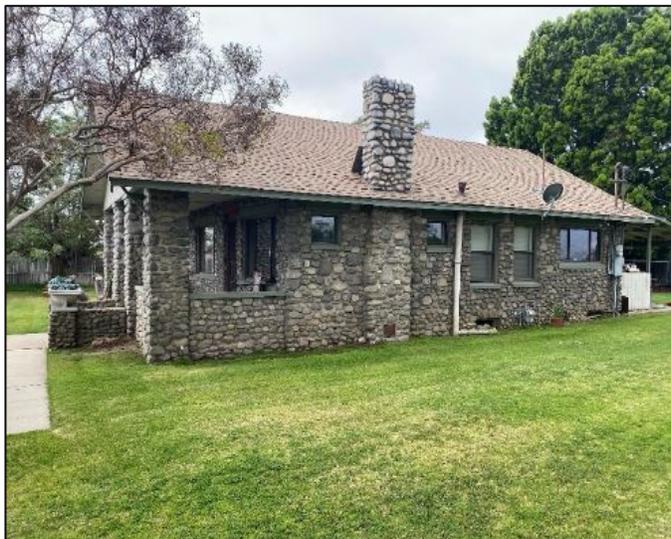
The 1,008 square foot residence was constructed in 1914 (est.) in the Craftsman architectural style. The residence is located at the eastern end of the parcel, has a rectangular footprint, a medium-pitched front-facing gabled roof and is clad in stone on all façades. The primary façade of the residence is symmetrical with thin horizontal wood clapboard and a square louver vent in the front-facing gable and triangular knee braces under the eaves. The primary façade is defined by its full-façade porch with four square columns clad in stone that extend from the roofline to the ground level. The primary façade is inset below the primary roofline. The porch is enclosed with an approximately 2-foot-tall wall clad in stone. A stoop constructed of stone, extends from the center of the porch with concrete planters set on top of the end caps. The door is flanked by aluminum Chicago-style windows with sliding sides and a central fixed light. Both windows also have bold concrete headers and wood.

The southern façade has minimal eave overhang. The façade has three single-hung aluminum windows with wood surrounds and concrete headers. The fourth window near the center of the façade has been boarded.

The northern façade has minimal eave overhang and window types including single-hung, fixed, and Chicago-style aluminum. An end-wall chimney constructed with stone is located near the eastern end of the façade.

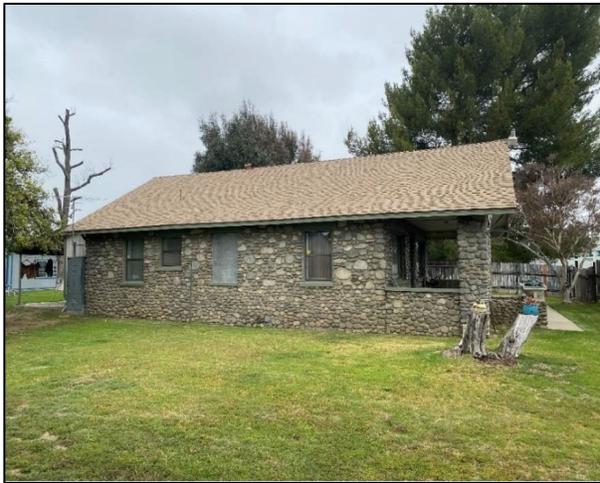
The western (rear) façade has an enclosed porch addition. There is thin horizontal wood clapboard and a square louver vent in the gable

and three triangular knee braces under the eave.

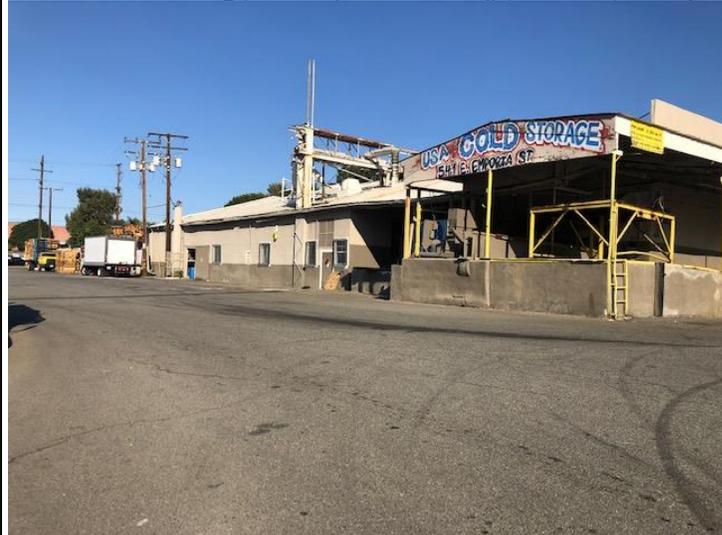
P5b. Description of Photo (view, date, accession #): Southern façade; view northwest; October 1, 2021

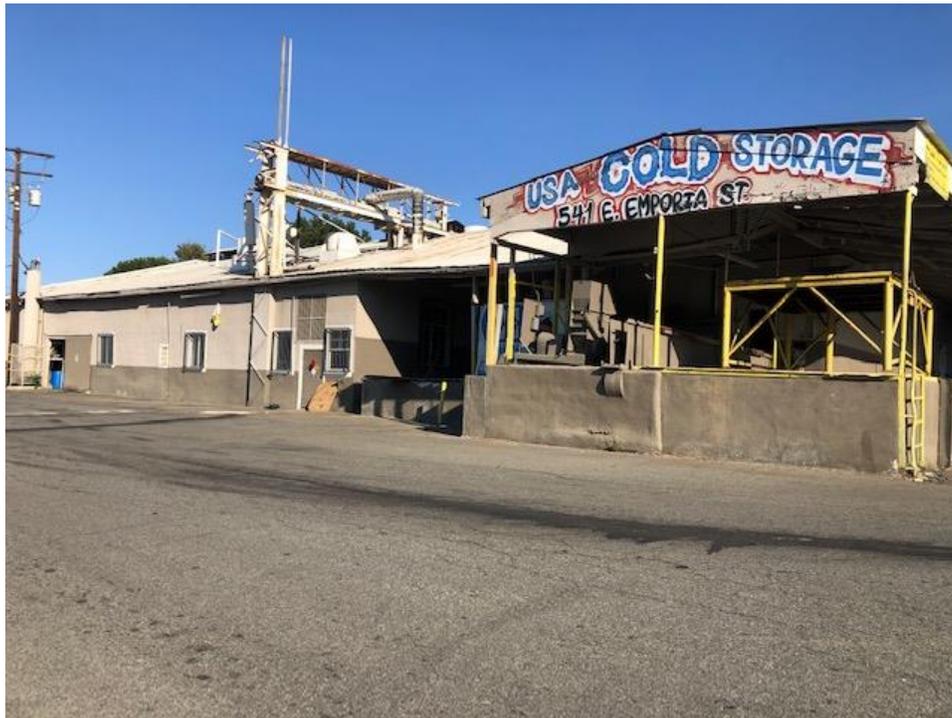
Southern Façade, view northwest

The building is a 1-story, rectangular industrial building which encompasses the entirety of its lot. It is clad in stucco with a medium-pitched, multi-gabled roof and tall parapet walls which run along the eastern and western façades (added post-1983). The concrete walkway along the eastern façade was extended post-1983 at the southwest corner to include an elevated concrete loading dock with gabled-roof cover supported by metal posts. The southern and eastern façades are visible from the public right-of-way with either sliding metal doors or large insulation doors and various window types and sizes, which have been altered/replaced at various dates along each façade. The northern and western façades are accessed through alleys with no fenestration on the northern façade and altered doors/windows on the western façade with security bars. The office is located at the northeast corner of the building and is accessed by a concrete walkway that runs the length of the façade. The building is in very poor condition.

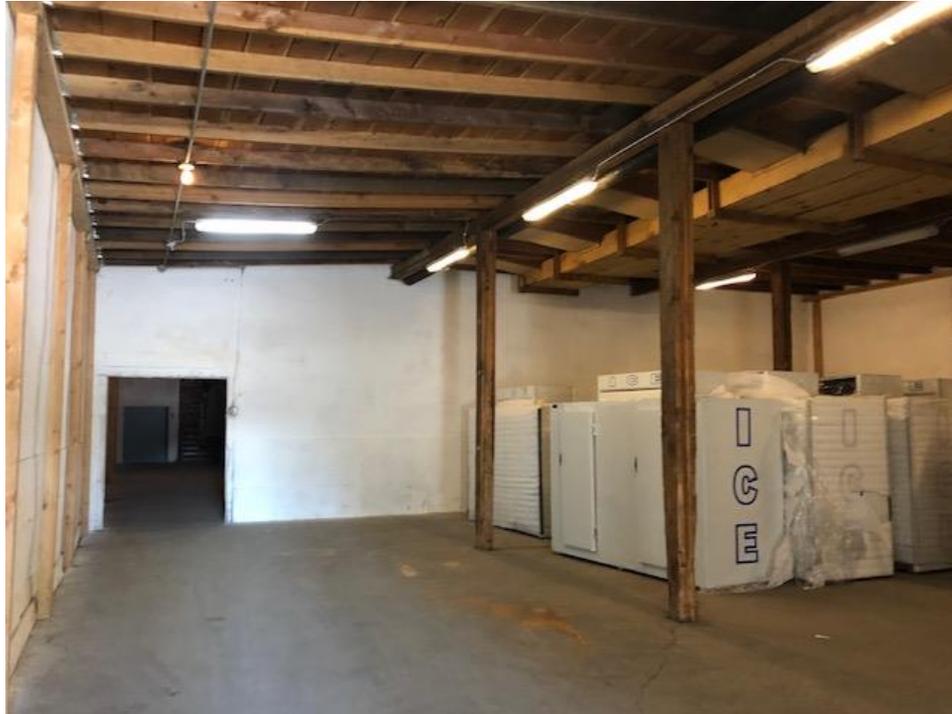
Interior Cold Storage

The interior of the building is divided into five spaces, with the northern four spaces used as cold storage and the southern space designated as a machinery room. The cold storage spaces have concrete floors (with corrugated sheet metal plates covering portions of flooring sporadically throughout), high-pitched ceilings with new wood trusses supported by wood posts, and insulated walls. Many of the doors have been updated with few wood doors remaining. The cold storage rooms are accessed along the eastern façade, and the machinery room is accessed along the southern façade. The machinery room holds the compressors and chillers, most of which are out of service, and the ice cutting machines.
