A Report Prepared for:

**ENVIRONMENTAL INITIAL SITE ASSESSMENT PHASE I
INTERSTATE 10 AT GROVE AVENUE AND FOURTH STREET INTERCHANGE
ONTARIO, CALIFORNIA**

Project No. 2008-007

April 24, 2008

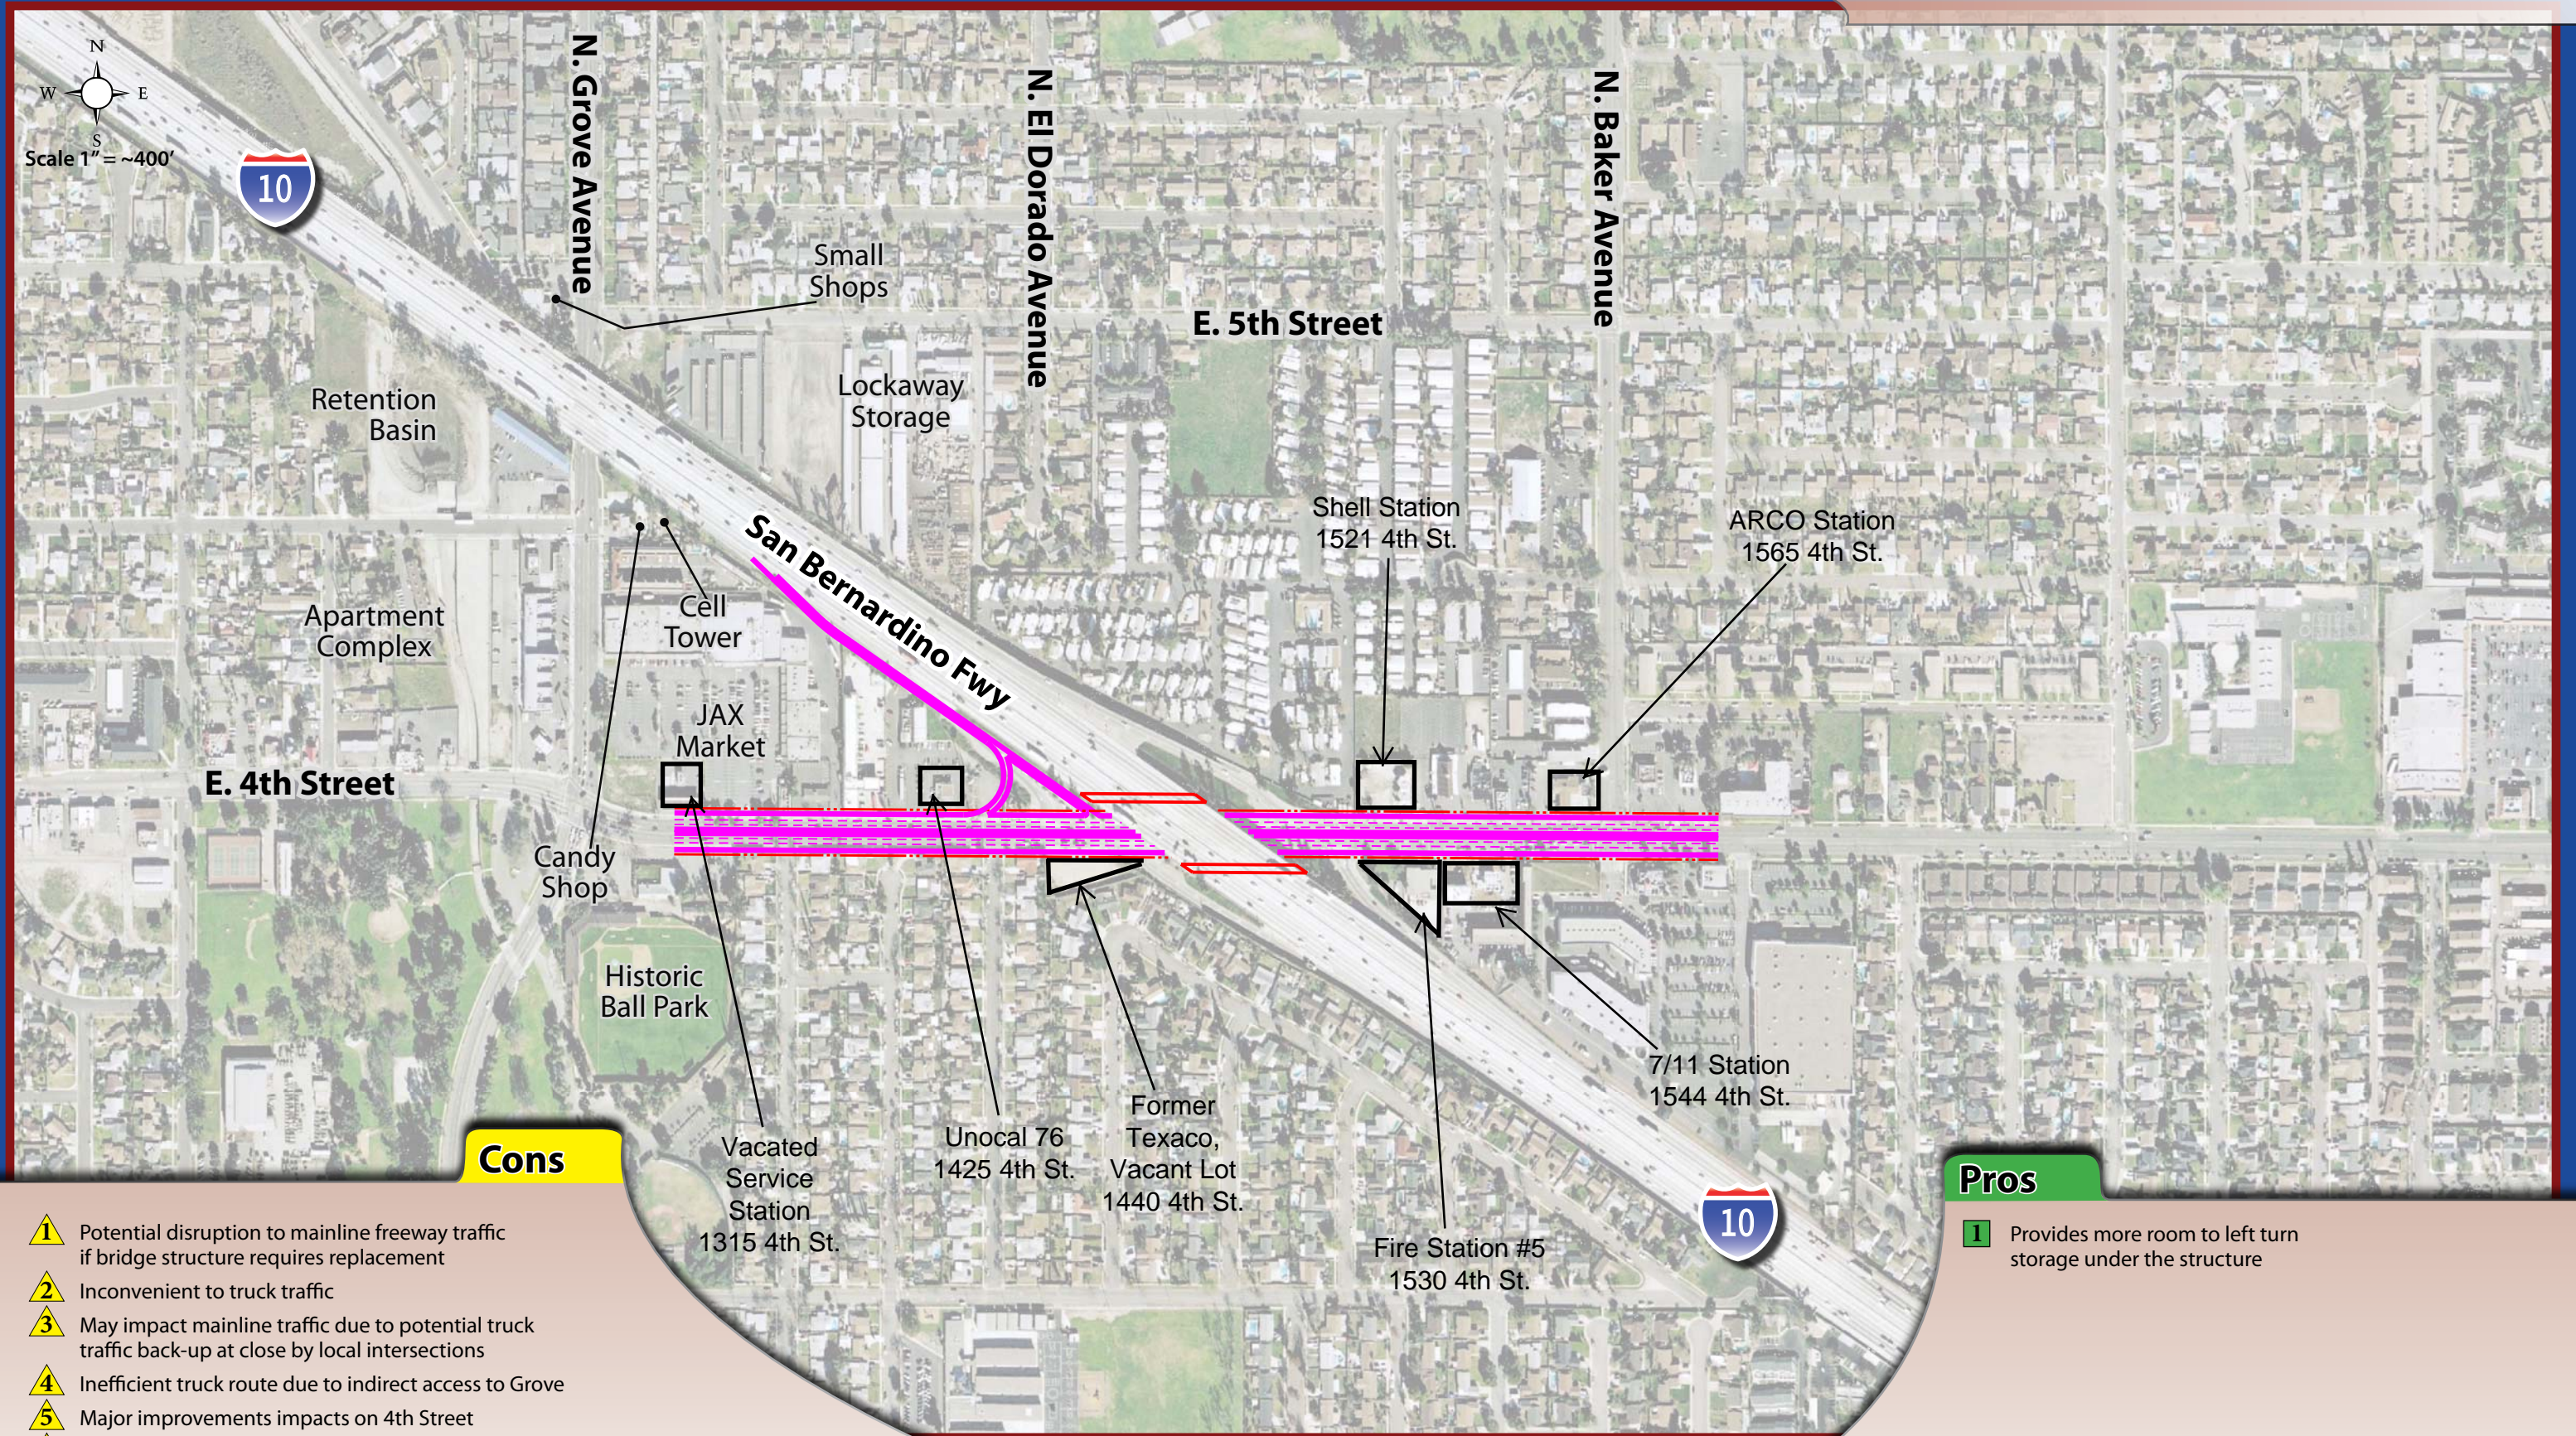
FIGURE 8
Interchange Alternative 6
 Bridge widening of 4th street

- 1 Potential disruption to mainline freeway traffic if bridge structure requires replacement
- 2 Inconvenient to truck traffic
- 3 May impact mainline traffic due to potential truck traffic back-up at close by local intersections
- 4 Inefficient truck route due to indirect access to Grove
- 5 Major improvements impacts on 4th Street
- 6 Extensive R/W acquisition along 4th street

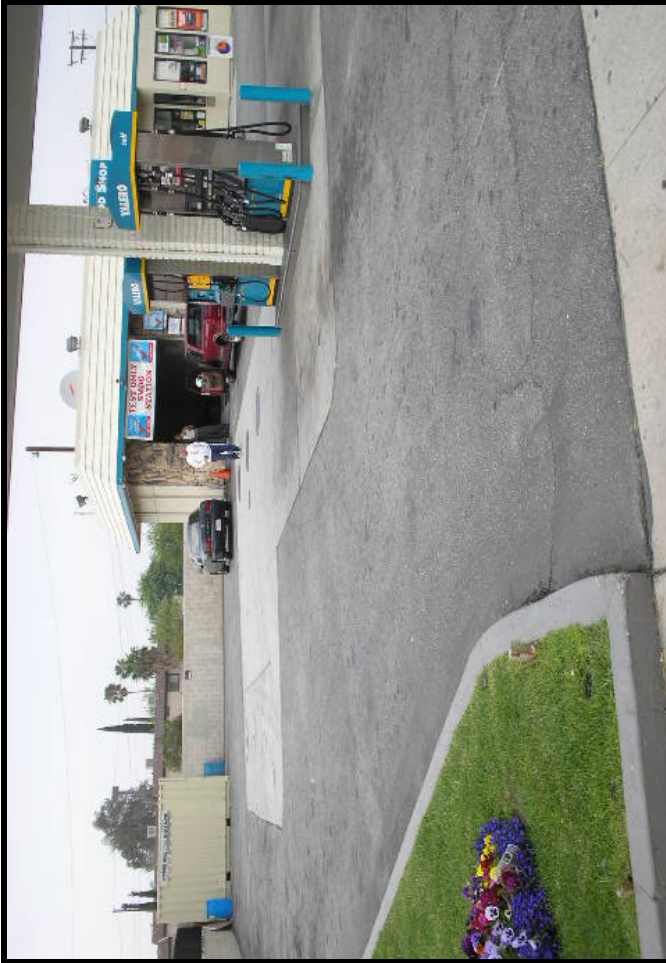
<p>Photo 10: Valero service station with USTs on the southwestern corner of the intersection of Grove Avenue and Princeton Street.</p>	<p>Photo 11: View north from Fourth Street on the west side of Grove Avenue showing ARCO service station on the northwestern corner of the intersection.</p>
<p>Photo 12: View east across Grove Avenue of a commercial plaza between Fourth Street and the I-10 Freeway.</p>	<p>I-10 at Grove Avenue & 4th Street Interchange Improvements Ontario, CA DYA Project No. 2008-007 Photos dated 4-2-08</p>

- An existing Valero Service Station, 1155 North Grove Avenue, with underground storage tanks (USTs), is located one block south of the I-10 freeway on the southwest corner of Grove Avenue and Princeton Street. This site is within a proposed construction ramp for Grove Avenue Interchange Alternative 1. It is assumed this parcel will need to be acquired and the USTs removed. In the event Alternative 1 is selected, Phase II soil sampling is recommended to investigate possible soil contamination on the site for the USTs and appurtenances. Review of the UST file for this site should be completed as part of the Phase II investigation.

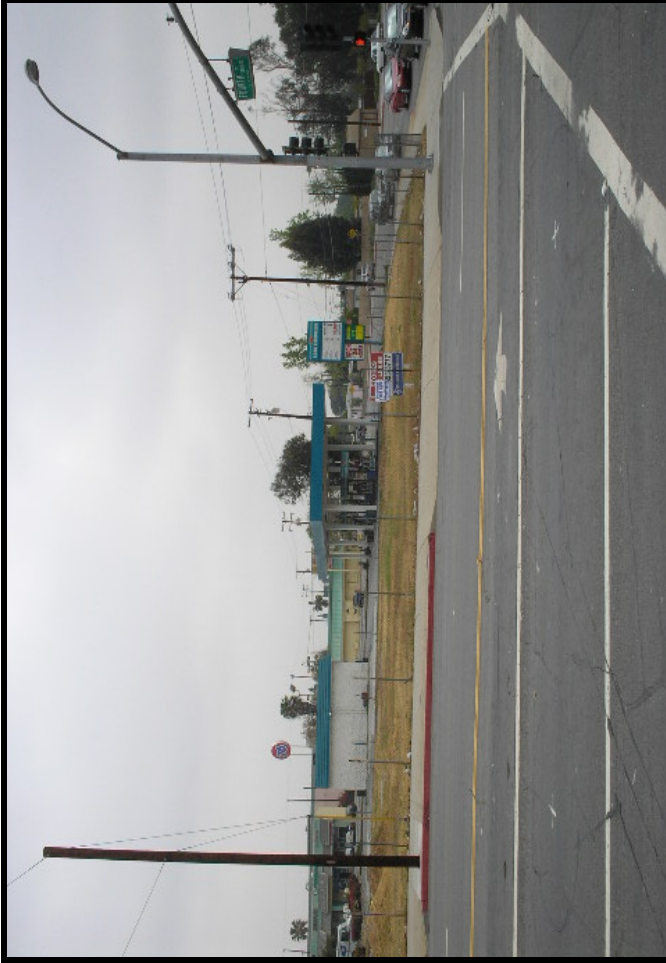
Photo 13:
View east across Grove Avenue on north side of Fourth Street. In the distance, a closed service station with remaining USTs beyond a vacant lot on the northeastern corner of the intersection

- An existing vacant lot at 1305 Fourth Street, formerly a Chevron Station with former USTs, is located on the northeastern corner of Grove Avenue and Fourth Street. This former UST site is not listed as a Leaking Underground Storage Tanks (LUST) case. However, the exact UST location and closure status is unknown. This site could impact the proposed Grove Avenue improvements. Review of the UST file for this site should be completed as part of the Phase II investigation.

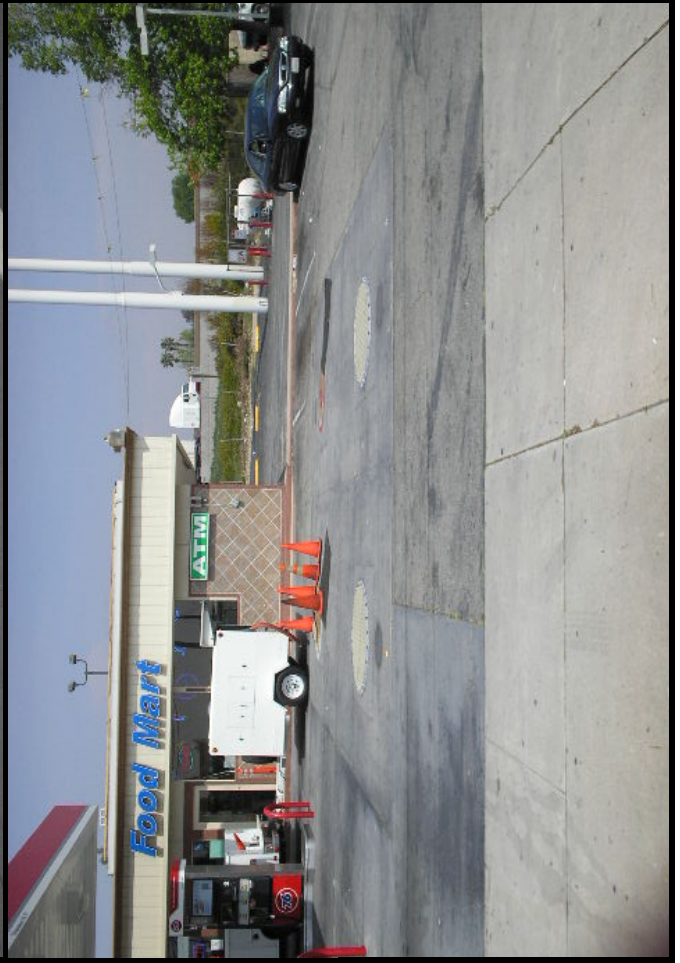
Photo 14:
View west on the north side of Fourth Street near the Freeway crossing, showing a Unocal service station with USTs near the street easement.

- Three additional existing service stations with existing USTs, all with closed LUST cases, are located on Fourth Street (Unocal 1425, 7/11 1544 and ARCO 1565) within the proposed Fourth Street Alternative 6 improvement segment. Detailed final design surveys for street improvements may encroach close to the existing USTs, piping and dispensers that are within 20 to 30 feet of existing street easements. This could result in a significant environmental impact if these UST facilities require relocation and Phase II file review and soil sampling would be recommended. At this stage of planning, DYA recommends that UST and dispenser locations in relation to street improvements be taken into consideration during evaluation of alternatives.

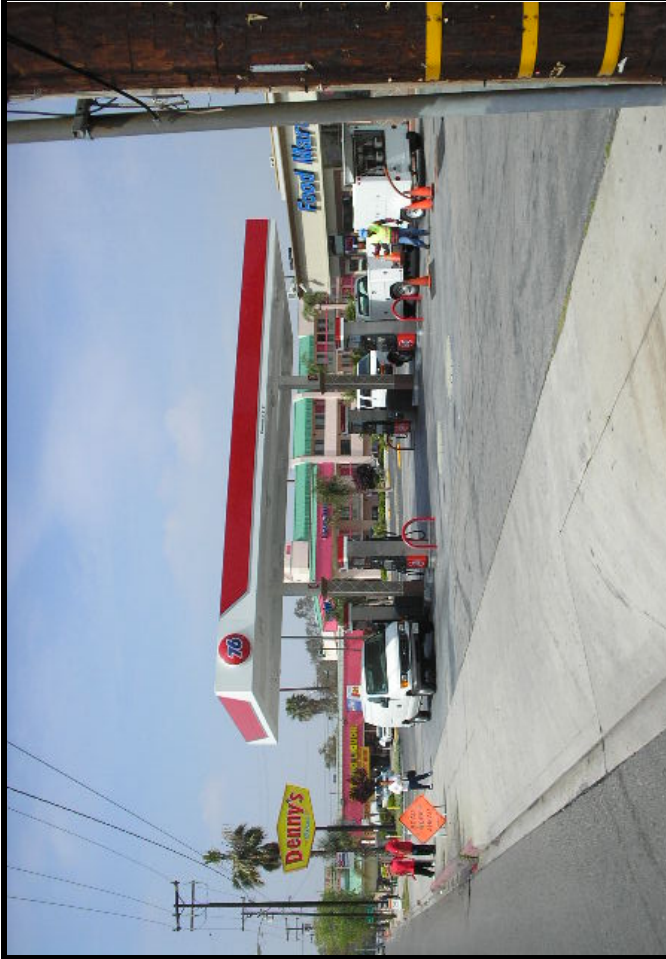
Photo 15:
View north on the north side of Fourth Street near the Freeway crossing, showing the Unocal service station with USTs near the street easement. Freeway is in the background.
